# **Liquefaction damage in the Kanto region caused by the 2011 off the Pacific coast of Tohoku Earthquake in Japan, and the land condition of damaged areas detected by time-series geospatial information**

**Mamoru KOARAI and Takayuki NAKANO**

(Published online: 18 December 2013)

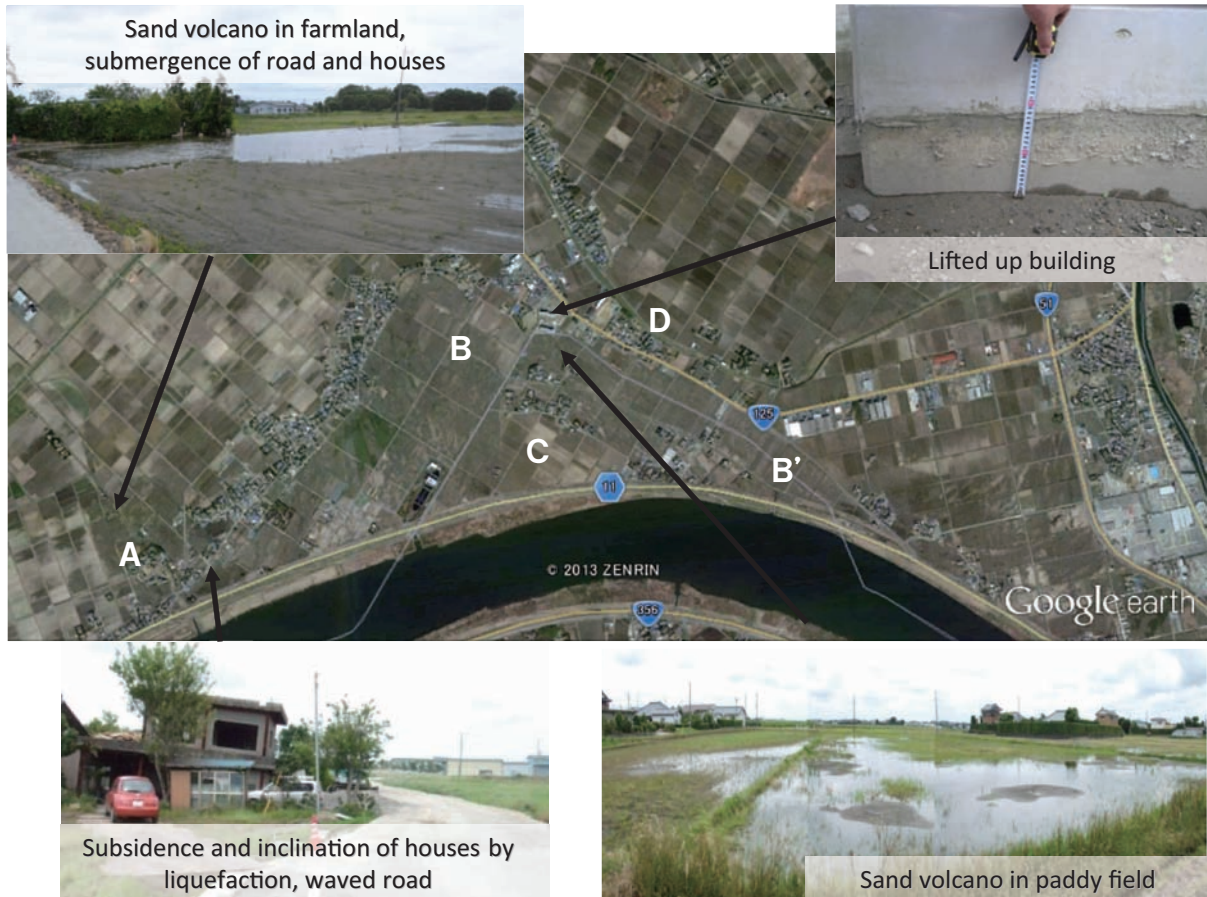
**Fig.5** Liquefaction damage in Kessa and Kokuno area (base imagery by Google Earth), and ground photos in a field survey on 16th June, 2011

and Rokkaku area, residential inclination, residential subsidence and undulated road deformation by liquefaction were observed (Fig.5; A). There are many traces of sand volcanoes in a paddy field that was once a river channel. In residential areas that has been filled up paddy fields, inclinations of houses and cracks in the land due to collapse of fill up mound were observed. Because of land subsidence over a large area, houses and roads became submerged under water. This area was swampland according to the Rapid Survey Map published in the 1880's and the topographical map published in 1950's showing scale of 1/25,000.

In the former river channel between the Nomayawara area and the Kokuno area of Katori City and the Naka-shinden area of Inashiki City, there are many traces of sand volcanoes in wide area making up paddy fields (Fig.5; B-B'). At an apartment located there, a little less than 20cm relative rise of the building structure was observed (Fig.5; B). On the other hand, evidence of liquefaction such as sand volcanoes were not observed in the Nomayawara area, the Kokuno area (Fig.5; C), and Naka-shinden area (Fig.5; D) which were land areas going back as early as the Meiji Era at least.

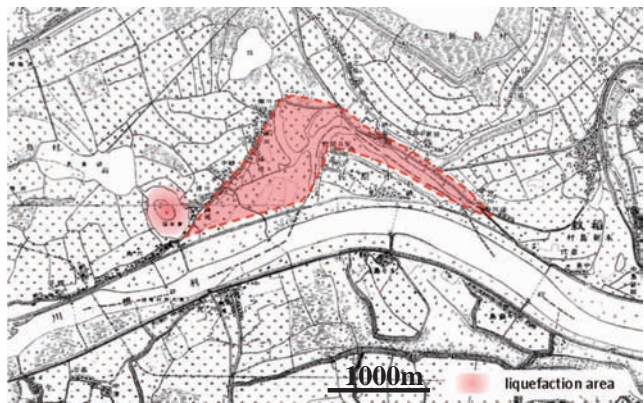
**Fig.7** Part of an old 1/25,000 scale topographical map “Sawara” published by GSI in 1946 and “Asou” published by GSI in 1954

published in 1950’s (Fig.7), you can see the former river stream which is not the main stream of the Tone River. Liquefaction occurred in this area of the old Tone River channel which was marshland.

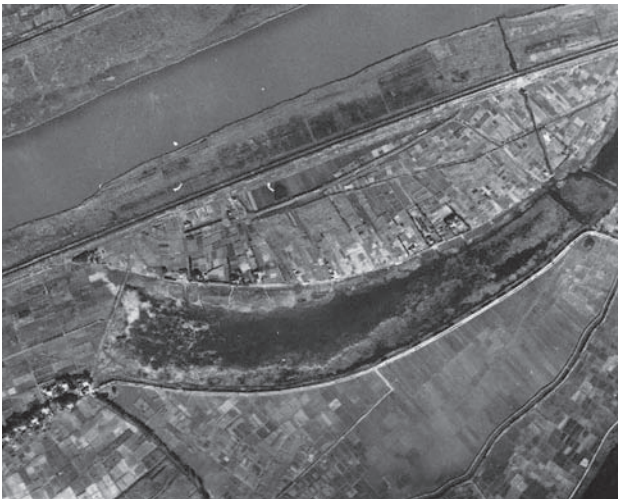
**Fig.10** Aerial photo of Kozaki Town taken by the US Army in 1947 (USA-R391-23)

Army (USA-R 391-23; Fig.10), it is easy to understand the process in which the old river channel was blocked and how the water dried up. Since it became the same ground height as a surrounding paddy field due to land reallocation, and the form of landscape was modified by human intervention, now, it is difficult to recognize the existence of the old river channel there. But it is possible to decipher the edge of the old river channel from the difference in a color tone in the color aerial photo taken in 2005 by GSI (CKT-2005-3X C10-22; Fig.11).

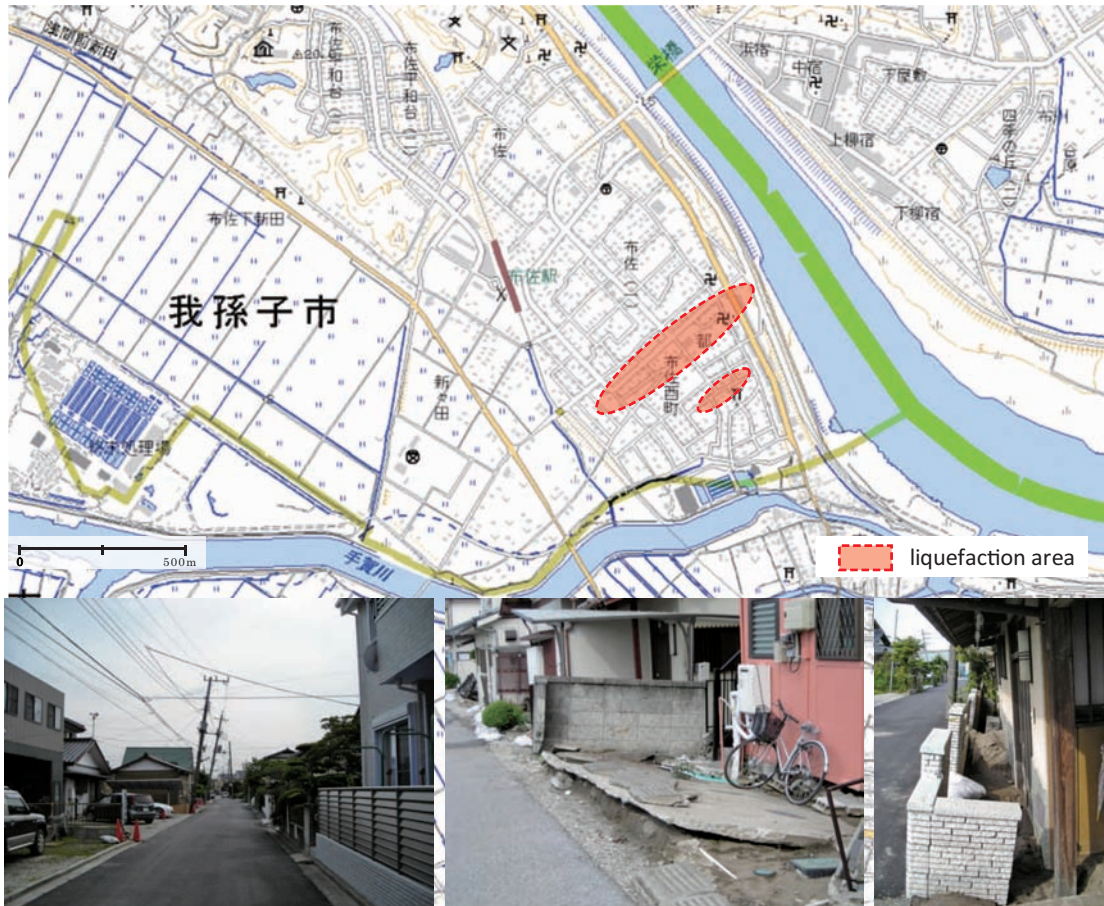
Fig.12 Liquefaction damage in the Fusa area, Abiko City (base map by GSI Maps), and ground photos taken in a field survey on 3rd June, 2011

Liquefaction was observed in the neighborhood of JR Fusa station in Abiko City, Chiba Prefecture. The heavy damaged area due to liquefaction is located within a limited narrow area (circled dashed line portion of Fig.12). Liquefaction damage, such as sand volcanoes, inclination

and subsidence of electric poles, concrete block walls and houses, and damage to roads was observed (Fig.12). This area had not reported liquefaction damage at the time of the Chiba East off Earthquake in 1987.

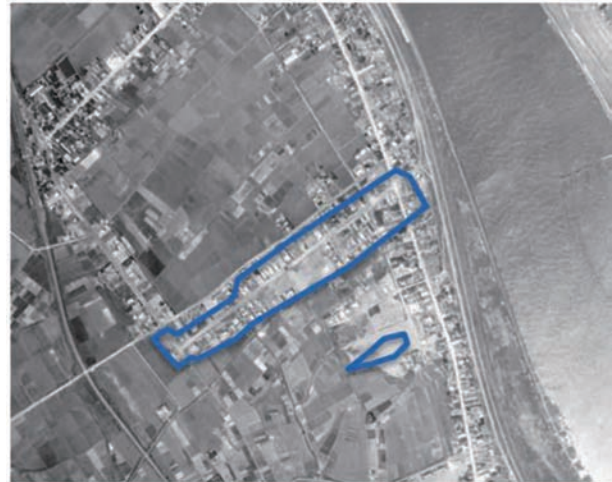
**Fig.14b** Aerial photo of the Fusa area taken by GSI in 1962 (MKT62-1 C11-17)

the long shaped water part. That long shaped water part had become a residential area by land reclamation, in the aerial photo taken by GSI in 1962 (MKT-62-1 C11-17), (Fig.14b).

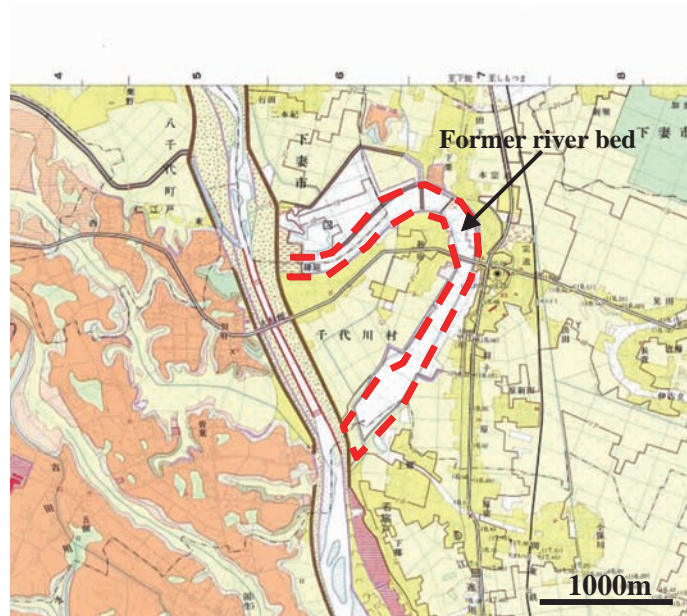
**Fig.15** Part of Land Condition Map “Mitsukaido” published by GSI in 1979

There is a low lying former river channel in a band across the Kinu area of Shimotsuma City, Ibaraki Prefecture. This landform is shown on the “Mitsukaido” Land Condition Map published by GSI (Fig.15). This former river channel sank, and land subsidence and relative ground water level rise are presumed to have

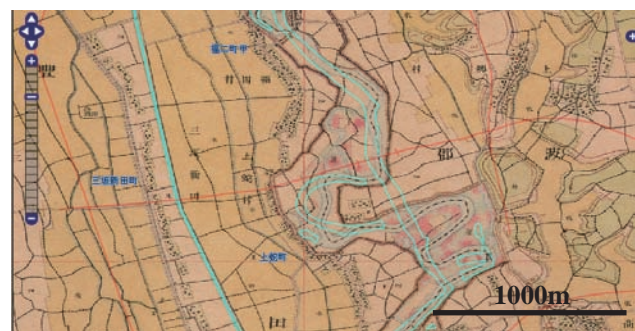
This old river channel was a main stream of the Kokai River as shown in the aerial photo taken by the US Army in 1948 (Fig.19b). The river channel of the Kokai River shortened and became a crescent lake as seen in the aerial photo taken by GSI in 1961 (Fig.19c). The position of the river channel in the Rapid Survey Map published in the early Meiji Era (Fig.19a) is different from the position of river channel in the aerial photo taken by the US Army. The location of the river channel in the early Meiji Era is the location of the present remains of the lotus field.
