## Responses of GSI to the 2016 Kumamoto Earthquake

### Disaster Management Office, Planning Department

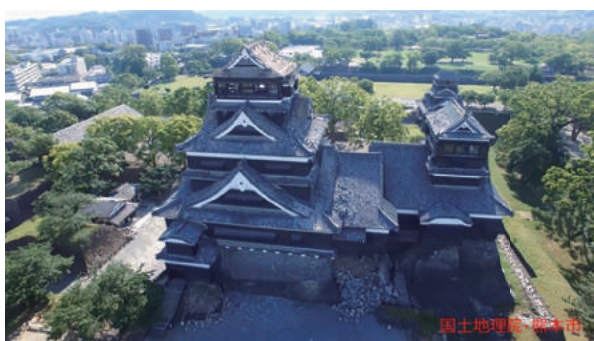
Photo 3 Castle tower of Kumamoto Castle (May 12)

Also, at the request of the City of Kumamoto, the damage condition of the stone wall of Kumamoto Castle was also measured between May 11 and May 13 (Photo 3). The purpose of emergency photographing using aircrafts is to promptly identify the damage situation over

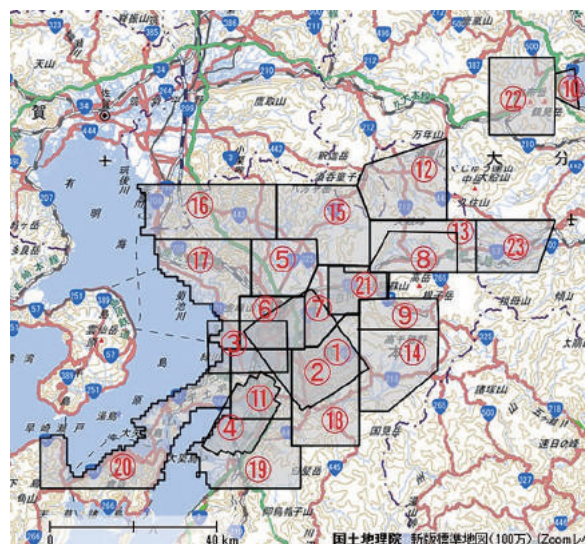
Fig. 3 Map of areas of vertical aerial photos for emergency response

a wide area and to that end, approximately 10,000 aerial photos were taken from April 15 to April 20 (Fig. 3, Table 1). They were promptly provided and made public and assisted during the first response for disaster as well as restoration period (National Mapping Department, 2016).

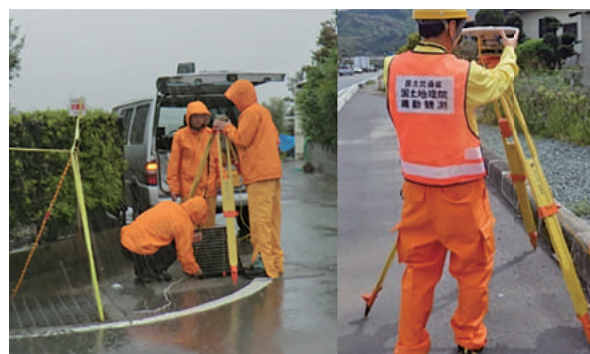
Photo 4 Emergency surveying of crustal deformations

Observation of urgent crustal deformation was carried out from May 3 to May 5 through emergency GNSS surveying focusing on locations where SAR interferometry did not produce clear results in order to grasp the whole aspect of ground subsidence and uplift caused by the earthquake (Miyahara et al., 2016) (Photo 4).

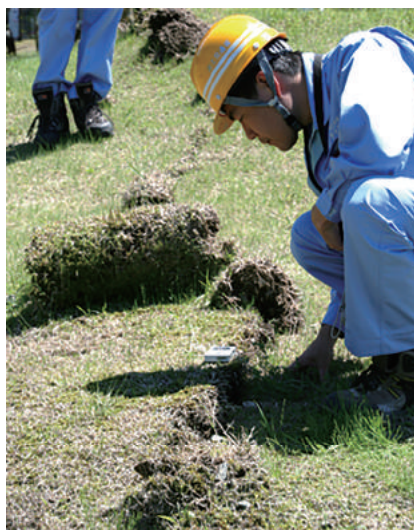
**Photo 5** Field Investigation on Ground Surface Displacements

Field investigation on ground surface displacements was carried out from May 10 to May 12 to confirm the actual situation at phase discontinuous locations as detected by SAR interferometry as well as ground surface displacements such as cracks, focusing on surface earthquake faults as extracted from aerial photointerpretation (Yoshida et al., 2016, Fujiwara et al., 2016) (Photo 5).

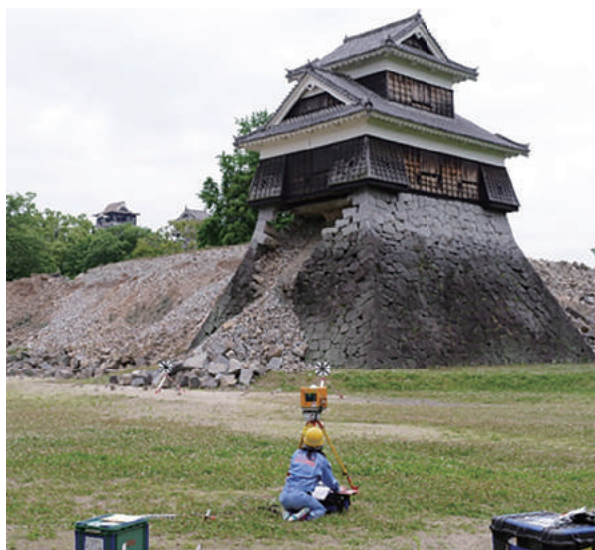
**Photo 6** Ground laser survey around Kumamoto Castle

At the request of the City of Kumamoto, ground laser survey was carried out between May 18 and May 22 to measure the damage condition around Kumamoto Castle, with focus on the stone wall and the acquired data was provided to the City of Kumamoto.

With respect to restoration of the stone wall at Kumamoto Castle, vertical and horizontal section drawings of stone wall were drafted based on the acquired data. These, together with the information on which stone material collapsed up to what point, were helpful in studying the collapse mechanism as well as restoration planning and were also used as the grounds for setting a stone wall incline (Photo 6).
