## Responses of Geospatial Information Department to the 2016 Kumamoto Earthquake

### Geospatial Information Department Disaster Countermeasures Group

*The Geospatial Information Department has provided a variety of geospatial information in connection with the Kumamoto earthquake which occurred in 2016. This report briefly describes the disaster responses.*

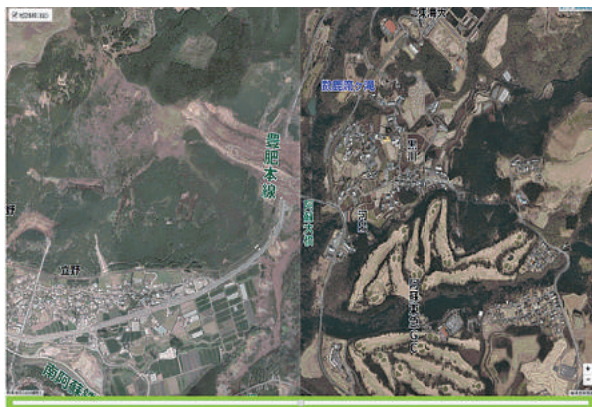
The comparison web page displayed a photo before the disaster on the right side and a photo after the disaster on the left side. The two photos could be compared by moving the scroll bar at the bottom of the web page to the right or left.

Fig. 5 Comparison web page before and after the disaster (Aso-ohashi Bridge area)

DCG extracted affected areas by referring to the news and disaster-related information. DCG provided comparison web page of five areas: Aso-ohashi Bridge area (provided on April 17), Nagano area (provided on April 18), Aso Shrine area, Kumamoto Castle area (provided on April 18) and Mashiki town area (provided on April 22). A massive landslide occurred near Aso-ohashi Bridge (Fig.5). In Nagano area and Minami Aso Village, several houses were caught in landslides. Many buildings were damaged and collapsed in Aso Shrine area and Kumamoto Castle area. Central area of Mashiki town suffered serious damage (Fig.6).

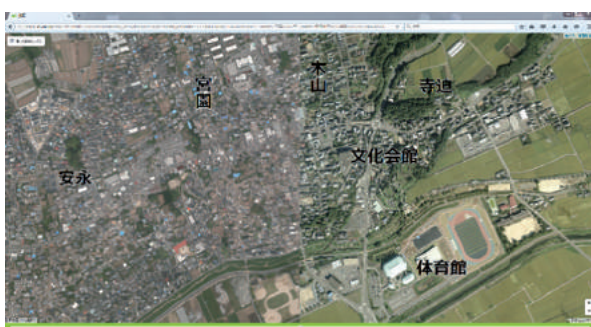
Fig. 6 Comparison web page before and after the disaster in aerial photograph (Mashiki central district)

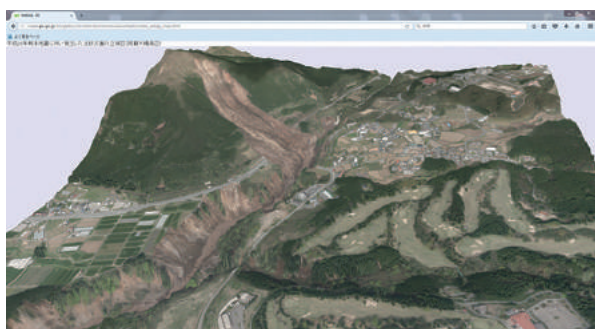
**Fig. 8** Example of 3D map at Aso-ohashi Bridge area built on WebGL

DCG created data for 3D maps that can be freely rotated on the browser, based on aerial photographs taken around the Aso-ohashi Bridge on April 16. The 3D map web page including a link to the Kumamoto earthquake website was published on April 18 (Fig.8). At first, the elevation information of this model was based on the ground elevation information before the earthquake. But, the elevation information was improved by using aerial photographs which were taken by Kunikaze III, the GSI's aircraft for survey, on April 16, the day of main shock. The revised version was provided on April 22 by using WebGL. The improved height was obtained by using digital surface model (DSM) which includes height of buildings and forests.

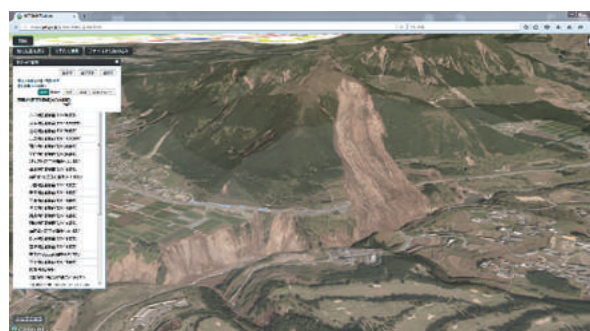
**Fig. 9** 3D display of GSI Maps on Globe (Minami Aso Village)

This makes it possible to display seamless 3D aerial photographs taken after the disaster (Fig.9).

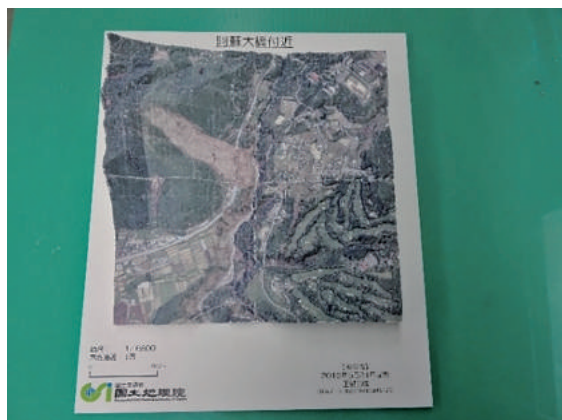
The height of the models was 5-meter mesh data of digital surface model (DSM) made from aerial photographs by National Mapping Department. These aerial photographs were taken by Kunikaze III on April 16, immediately after the main shock. The height data is created by stereo matching of overlapping pictures, which represents the surface after the Kumamoto earthquake.

**Photo 1** 3D models provided to Kumamoto Prefectural Government (DSM after the disaster)

DCG has created 3D models of the Aso-ohashi Bridge area and provided them to the Disaster Management Headquarters and Kumamoto Prefectural Government. According to the request of the Kumamoto Prefectural Government, the 3D models (Photo 1) were provided on April 19, April 27, April 30 and June 24, through the Disaster Management Headquarters.

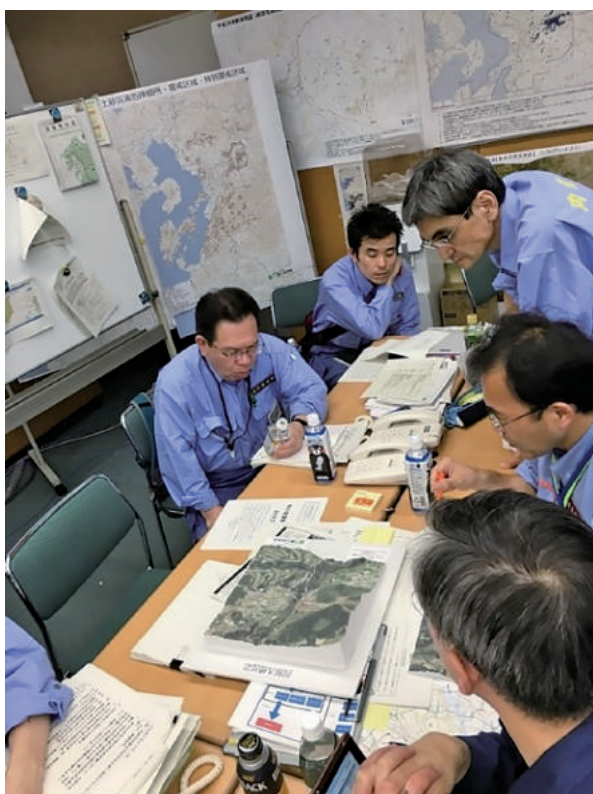
The model was used as a reference material to discuss carry-in route of heavy equipment and to help senior ministry officials understand the situation at the Disaster Management Headquarters (Photo 2).

**Photo 2** Example of use of 3D models in the Disaster Management Headquarters
